Consistency of Paving Grade Asphalts At Various Temperatures

State of California
Department of Public Works
Division of Highways
Materials and Research Department

It is recommended that the durability of aluminum culvert material be continuously monitored so as to confirm or modify, through added field experience, the culvert use recommendations that are shown in the following table
"Recommended Use of Minimum Gage Thickness of Corrugated Aluminum Pipe for Anticipated 25-year Maintenance-free Service."

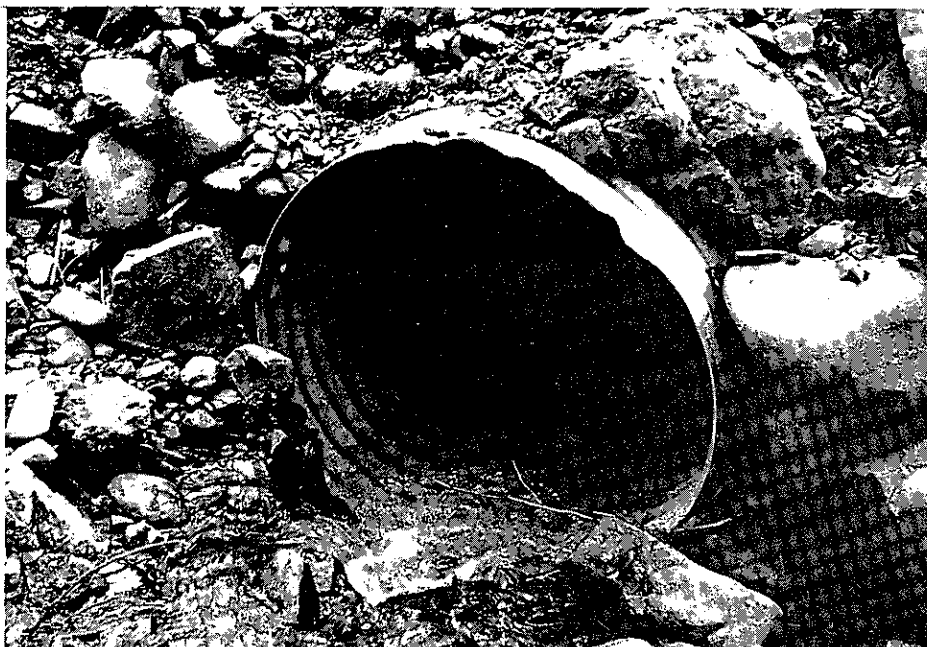
Figure 1

Inlet of test
pipe - aluminum
section

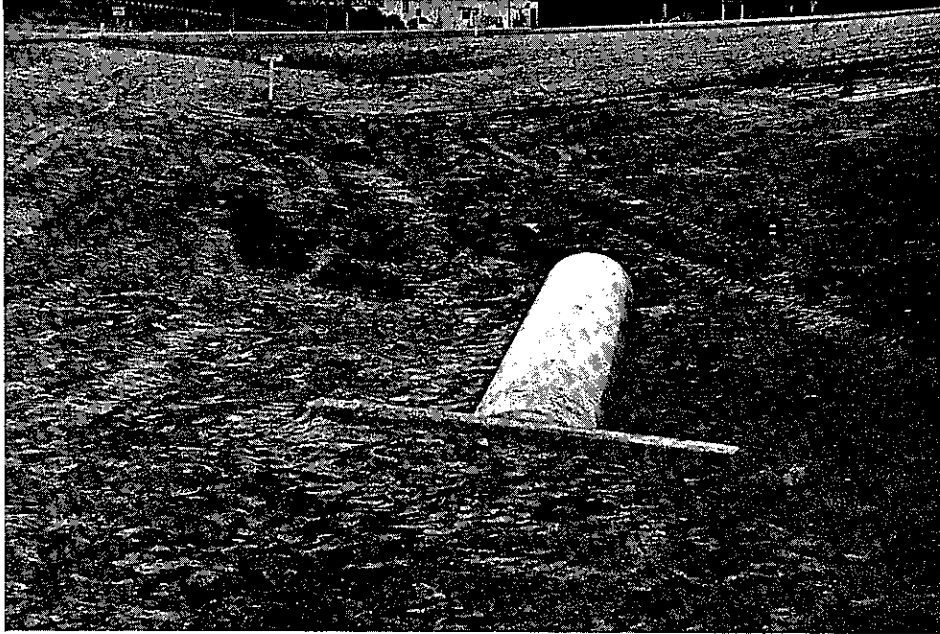
Aluminum culvert,
field test site.
(Exposed pipe sub-
sequently backfilled)
